Manhole Inspection Summary

Manhole # S25A__009MH

Insp Date: **4/6/09 8:25 AM**

Location Address: **1108 HARLEM AVE**

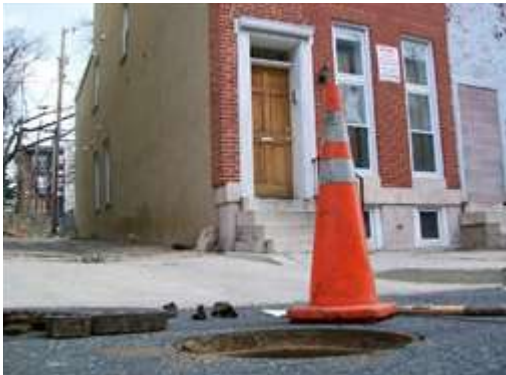
Location View

BROKE AND REPLACED 24" SANITARY LID

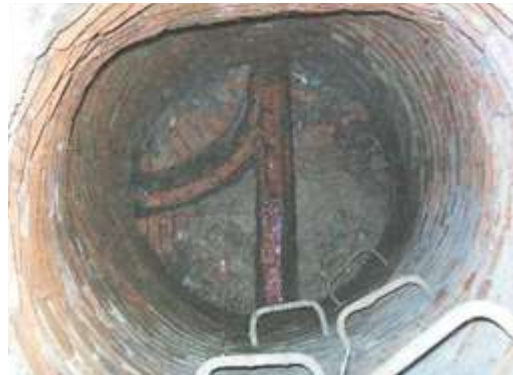
Top View

BROKEN LID

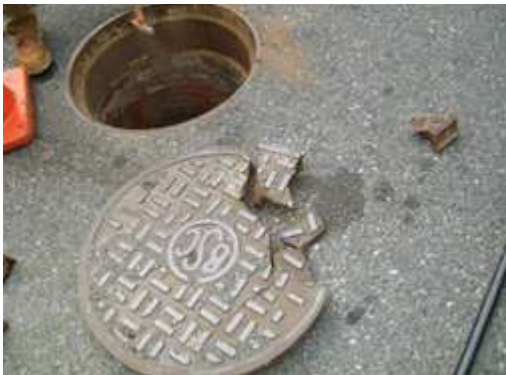
BROKE OPEN MANHOLE

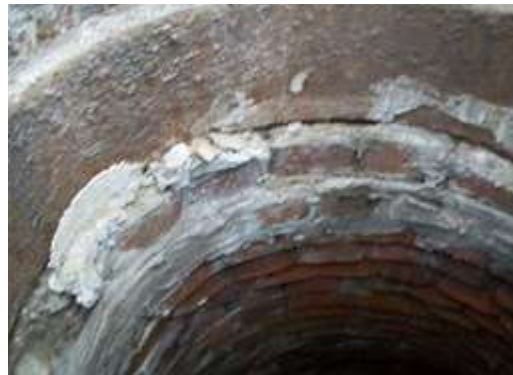
Defect 2

Offset: **2** (in.)

FRAME OFFSET 2"

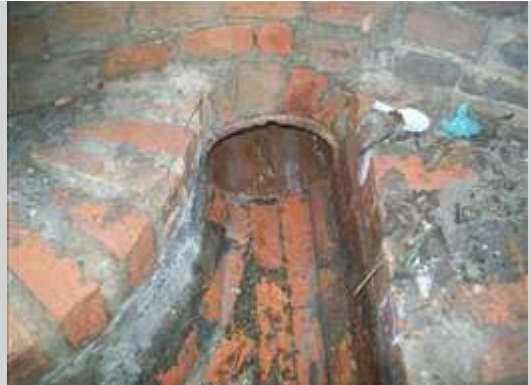
12 O'Clock Outflow

8 in. Circular Gravity Sewer
Pipe Out @ 12 O'Clock

Invert Depth: **9.83** (ft.) Flow Characteristics: **Slow**

Infiltration: **None**

Pipe Seal Cond: **Sound**

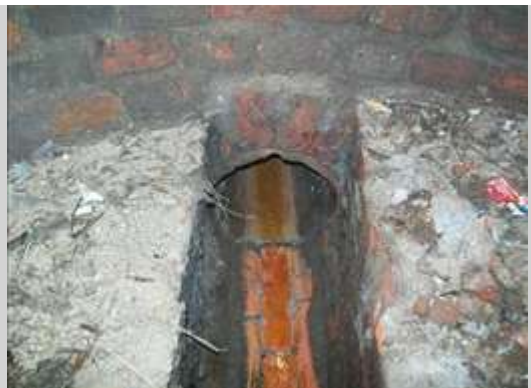
6 O'Clock Inflow

8 in. Circular Gravity Sewer
Pipe In @ 6 O'Clock

Invert Depth: **9.66** (ft.) Flow Characteristics: **Slow**

Infiltration: **None**

Pipe Seal Cond: **Sound**

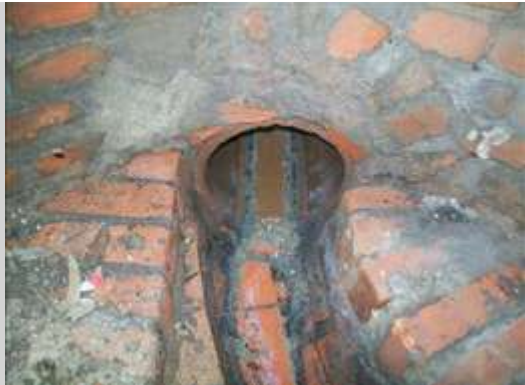
9 O'Clock Inflow

Pipe In @ 9 O'Clock

Invert Depth: **9.58** (ft.) Flow Characteristics: **Slow**

Infiltration: **None**

Pipe Seal Cond: **Sound**
